Management  
Survey Report  
Of:

Whitley Library  
205 Northumberland Avenue  
Reading

Reading Borough Council

| Site: | 2387, Whitley Library | www.armstrong-york.com | Project: | B-13473 |

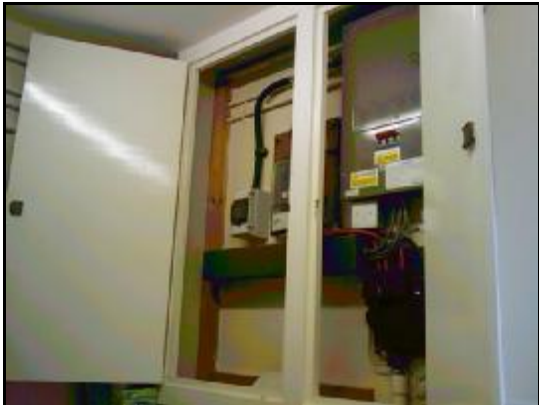
| Building | Main Building | UID/Photo no. | 37437 |

| Area surveyed | Ground Floor/007 Kitchen | | |
| Description | Door & Lining Panels | | |
| Item description | Insulating board | | |
| Initial risk assessment | <b>No Asbestos Detected</b> | | |
| Comments | Door and lining panels to electric cupboard to wall. | | |

| Recommendation | No action required | | |

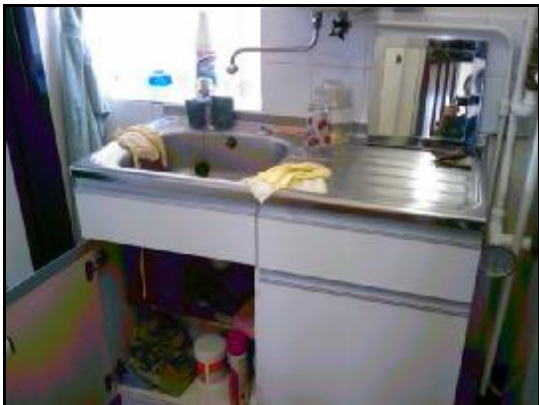
| Building | Main Building | UID/Photo no. | 37438 |

| Area surveyed | Ground Floor/007 Kitchen | | |
| Description | Sink Pad | | |
| Item description | Bitumen | | |
| Initial risk assessment | <b>No Asbestos Detected</b> | | |

| Recommendation | No action required | | |

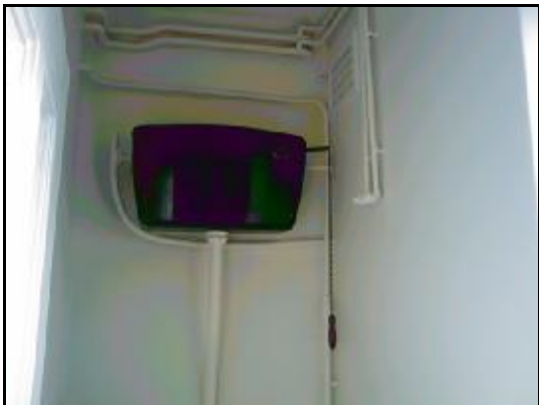
| Area surveyed | Ground Floor/006 W.C. | | |
| Description | Toilet Cistern | | |
| Item description | Reinforced composites | | |
| Condition | 0 - Good | | |
| Asbestos score / type | Amphibole asbestos excluding crocidolite | | |
| Material score | 3 | | |
| Initial risk assessment | <b>Very Low Risk</b> | | |

| CLIENT SAMPLE No. | Sample Location/ Description:<br><small>(Any Record of; location or Description of Sample, is outside the scope of our accreditation for the identification of asbestos.)</small> | Fibre Type Detected |
|---|---|---|
| 3 | Main Building, Ground Floor, Location 006: W.C.. Toilet Cistern - Reinforced composites | Amosite |

| Recommendation | Label & manage | | |

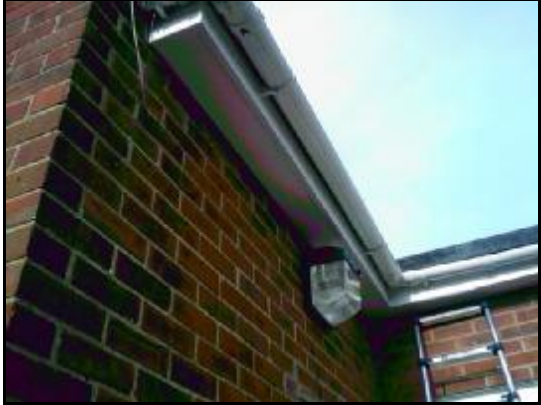
| Building | Main Building | UID/Photo no. | 37440 |

| Area surveyed | Ground Floor/500 External | | |
| Description | Soffits | | |
| Item description | Cement | | |
| Extent | 12LinearM | | |
| Condition | 0 - Good | | |
| Asbestos score / type | Chrysotile | | |
| Material score | 3 | | |
| Initial risk assessment | <b>Very Low Risk</b> | | |

| CLIENT SAMPLE No. | Sample Location/ Description:<br><small>(Any Record of; location or Description of Sample, is outside the scope of our accreditation for the identification of asbestos.)</small> | Fibre Type Detected |
|---|---|---|
| 4 | Main Building, Ground Floor, Location 500: External. Soffits - Cement | Chrysotile |

| Recommendation | Label & manage | | |

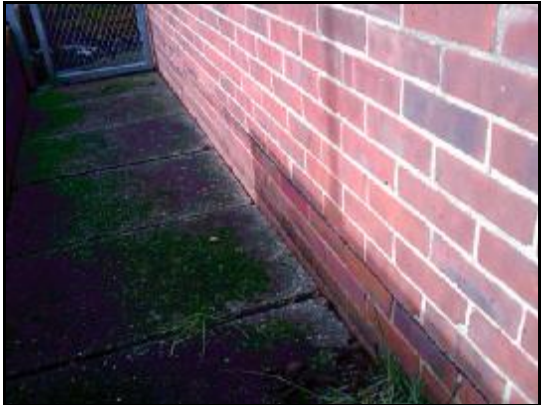
| Building | Main Building | UID/Photo no. | 37442 |

| Area surveyed | Ground Floor/500 External | | |
| Description | Dampm Proof Course | | |
| Item description | Bitumen | | |
| Extent | 80LinearM | | |
| Condition | 0 - Good | | |
| Asbestos score / type | Chrysotile | | |
| Material score | 2 | | |
| Initial risk assessment | <b>Very Low Risk</b> | | |

| CLIENT SAMPLE No. | Sample Location/ Description:<br><small>(Any Record of; location or Description of Sample, is outside the scope of our accreditation for the identification of asbestos.)</small> | Fibre Type Detected |
|---|---|---|
| 5 | Main Building, Ground Floor, Location 500: External. Dampm Proof Course - Bitumen | Chrysotile |

| Recommendation | Label & manage | | |

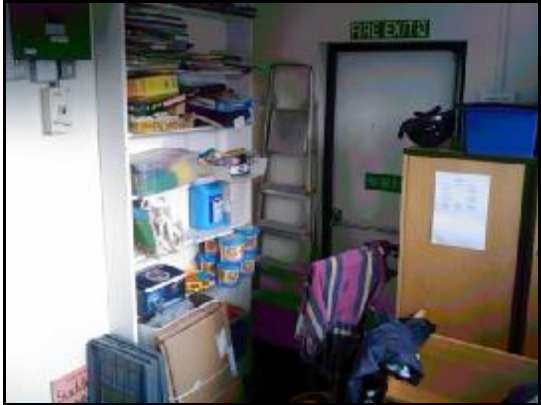
| Building | Main Building | UID/Photo no. | 37436 |

| Area surveyed | Ground Floor/003 Store | | |
| Initial risk assessment | <b>No Asbestos Detected</b> | | |

| Recommendation | No action required | | |

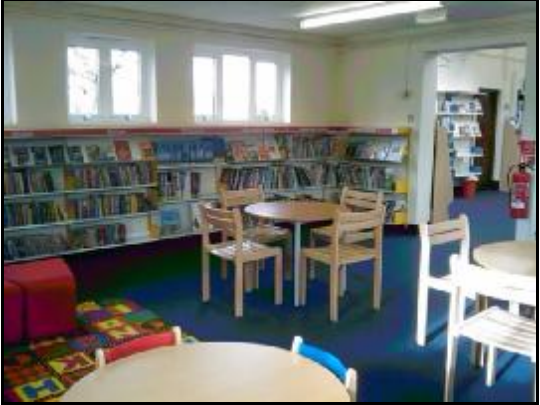
| Building | Main Building | UID/Photo no. | 37435 |

| Area surveyed | Ground Floor/002 Library | | |
| Initial risk assessment | No Asbestos Detected | | |

| Recommendation | No action required | | |

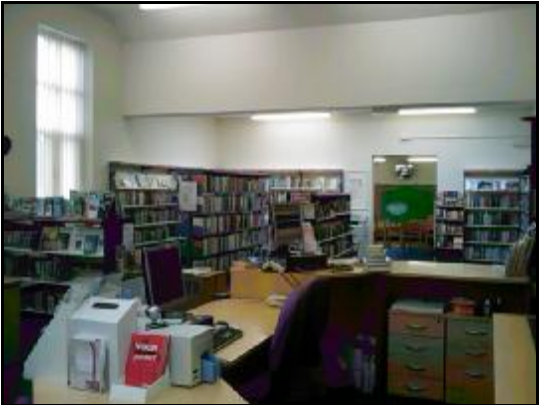
| Building | Main Building | UID/Photo no. | 37434 |

| Area surveyed | Ground Floor/001 Library | | |
| Initial risk assessment | No Asbestos Detected | | |
| Comments | No access to high level loft. | | |

| Recommendation | No action required | | |

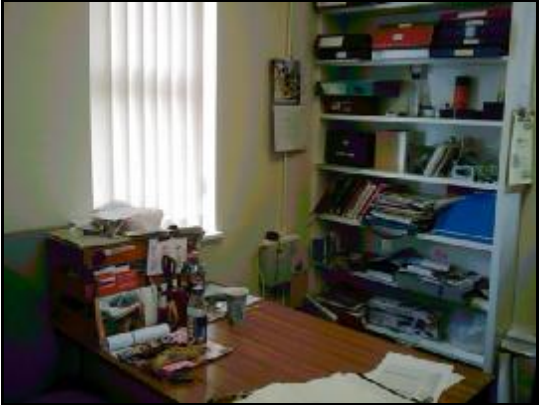
| Building | Main Building | UID/Photo no. | 37433 |

| Area surveyed | Ground Floor/004 Office | | |
| Initial risk assessment | No Asbestos Detected | | |

| Recommendation | No action required | | |

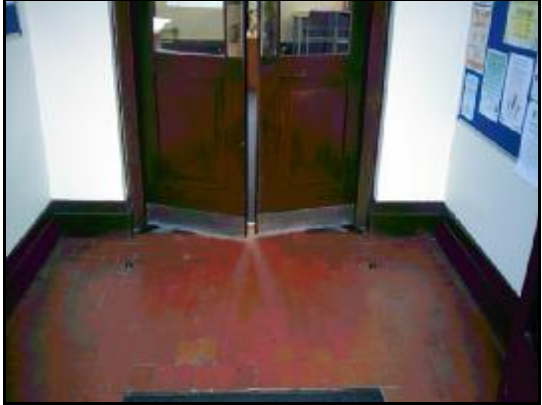
| Building | Main Building | UID/Photo no. | 37431 |

| Area surveyed | Ground Floor/005 Lobby | | |
| Initial risk assessment | No Asbestos Detected | | |

| Recommendation | No action required | | |
