**RE-INSPECTION, ASSESSMENT AND REGISTER
OF
ASBESTOS CONTAINING MATERIALS
AT
WHITLEY LIBRARY, NORTHUMBERLAND
AVENUE, READING, RG2 7PX
FOR
READING BOROUGH COUNCIL**

J018554

AUGUST 2018

| Report Type: | | Asbestos Re-inspection Report |

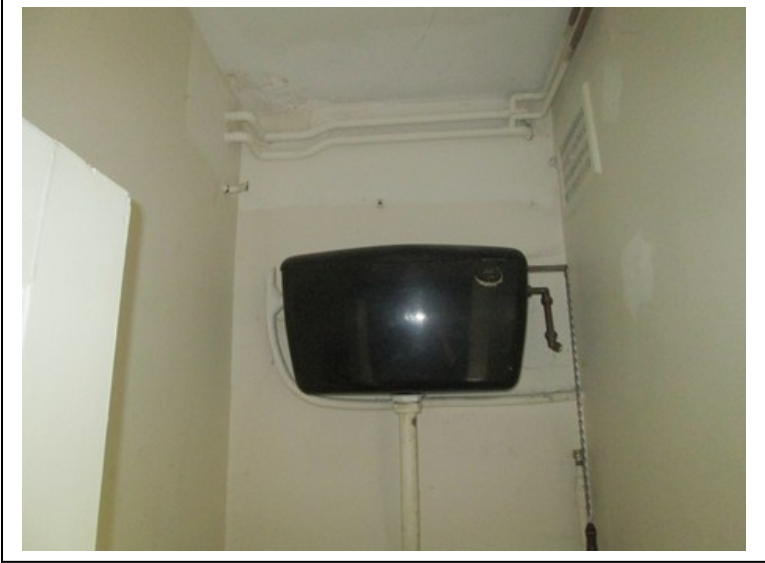
| Photo Reference: | Armstrong York Report Ref 37439.03 |

| Sample /Observation Number | Location, position and description | Product | Extent, condition, surface treatment and other comments | Material Risk Rating | | Priority Risk Rating | | Total Risk Rating | Recommendations |
|--|--|---|---|---|---|---|---|---|--|
| Armstrong York Report Ref 37439 Sample 03 | Block A Ground floor Room 00_006 - W.C Toilet cistern | Plastic | 1 Item Low damage Reinforced composite material No access code, presume still in situ | 1 | 4 Very low | 1 | 4 Very low | 8 Low | Manage asbestos containing material (ACM) in place |

| Photo Description: | Block A, Ground floor, Room 00_006 - W.C – plastic toilet cistern containing asbestos |

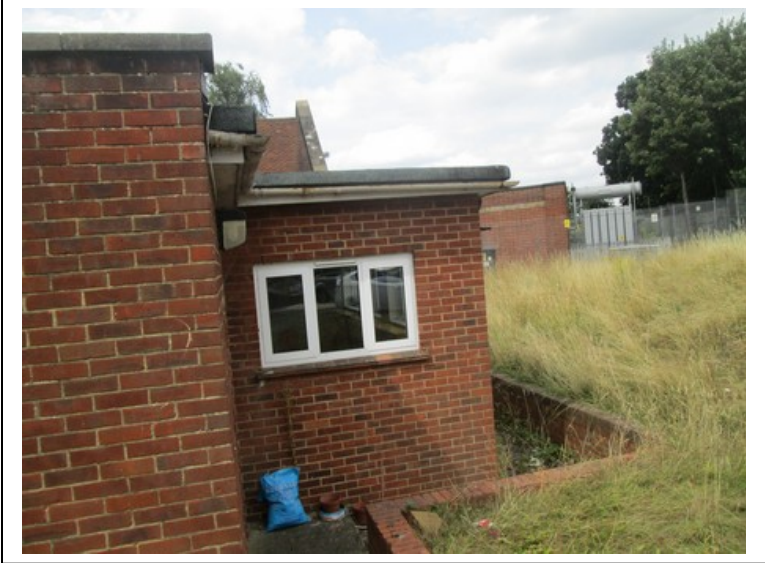
| Photo Reference: | Armstrong York Report Ref 37440.04 |

| Sample /Observation Number | Location, position and description | Product | Extent, condition, surface treatment and other comments | Material Risk Rating | | Priority Risk Rating | | Total Risk Rating | Recommendations |
|--|--|---|---|---|---|---|---|---|--|
| Armstrong York Report Ref 37440 Sample 04 | Block A Ground floor External - outside rooms 00_002 and 00_003 Cement soffits | Cement | 12m Low damage Sealed | 1 | 4 Very low | 0 | 1 Very low | 5 Low | Manage asbestos containing material (ACM) in place |

| Photo Description: | Block A, ground floor, External to rooms 00_002 and 00_003 - Asbestos cement soffits |

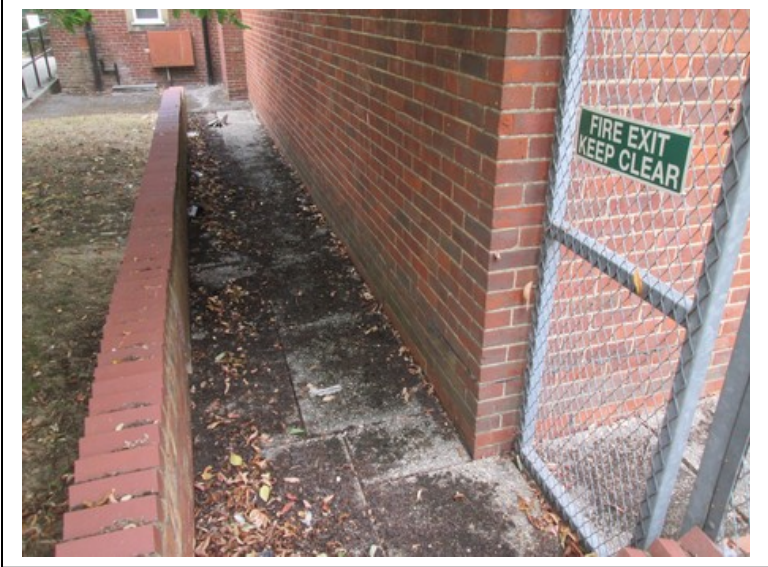
| Photo Reference: | Armstrong York Report Ref 37442.05 |

| Sample /Observation Number | Location, position and description | Product | Extent, condition, surface treatment and other comments | Material Risk Rating | | Priority Risk Rating | | Total Risk Rating | Recommendations |
|--|--|---|---|---|---|---|---|---|--|
| Armstrong York Report Ref 37442 Sample 05 | Block A Ground floor External Bitumen damp proof course | Bitumen | 80m Low damage Reinforced composite material | 1 | 3 Very low | 0 | 1 Very low | 4 Very low | Manage asbestos containing material (ACM) in place |

| Photo Description: | Block A, ground floor, external – bitumen damp proof course containing asbestos |
