Asbestos Re-Inspection Report
for
2-5 Craven Road

Prepared For:	Berkshire Healthcare NHS Trust
Prepared By:	Advance Environmental Limited
Date of Survey:	June 2017
Review Date:	June 2018

Client Name	BERKSHIRE HEALTHCARE NHS TRUST
Client Contact	PHILIP WATKINS
Client Address	7-9 CREMYLL ROAD READING RG1 8NQ
Site Address	2-5 CRAVEN ROAD READING RG1 5LF
Re inspection Date	07/06/17
Surveyor(s)	PAUL CARROLL

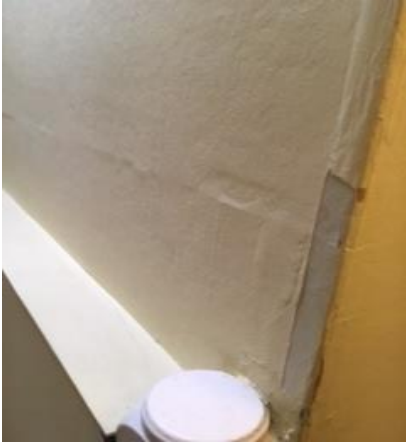
Ref	Building	Floor	Area/Room	Position
1224	Main	Second	Stairwell	ceiling

Material Description		Material Risk
	AIB Boxing		6
	Additional Information		Priority Risk
	Item was in good condition		4
	HSE Notifiable/Licensed	Yes	Total Score
Recommendation	Manage	10	
Review Timescale	12 Months

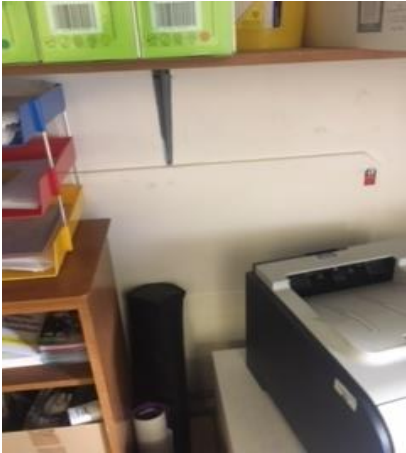
Ref	Building	Floor	Area/Room	Position
1222	Main	Second	Office 37	Fireplace

Material Description		Material Risk
	AIB Panel to Fireplace		5
	Additional Information		Priority Risk
	Item was in good condition		4
	HSE Notifiable/Licensed	Yes	Total Score
	Recommendation	Manage	9
Review Timescale	12 Months

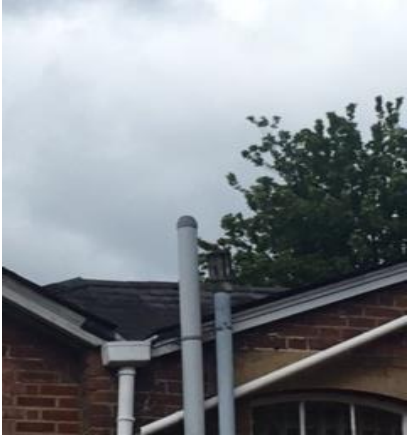
Ref	Building	Floor	Area/Room	Position
1226	Main	External	External	Wall

Material Description		Material Risk
	Flue pipe		4
	Additional Information		Priority Risk
	Item was in good condition		1
	HSE Notifiable/Licensed	No	Total Score
	Recommendation	Manage	5
Review Timescale	12 Months

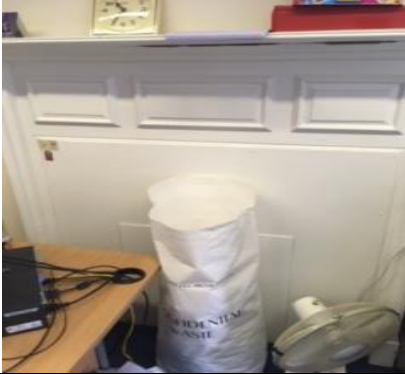
Ref	Building	Floor	Area/Room	Position
1214	Main	Ground	Room 28	Fireplace

Material Description		Material Risk
	AIB Panel to Fireplace		5
	Additional Information		Priority Risk
	Item was in good condition		4
	HSE Notifiable/Licensed	Yes	Total Score
	Recommendation	Manage	9
Review Timescale	12 Months

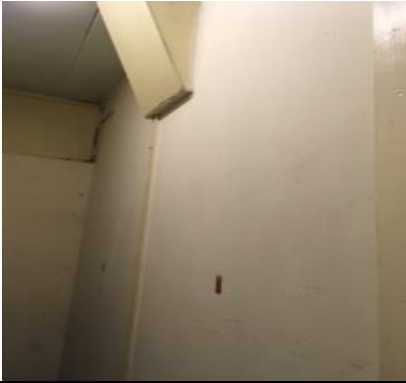
Ref	Building	Floor	Area/Room	Position
1216	Main	Ground	Store	Wall

Material Description		Material Risk
	AIB wall		6
	Additional Information		Priority Risk
	Item was in good condition		2
	HSE Notifiable/Licensed	Yes	Total Score
	Recommendation	Manage	8
Review Timescale	12 Months

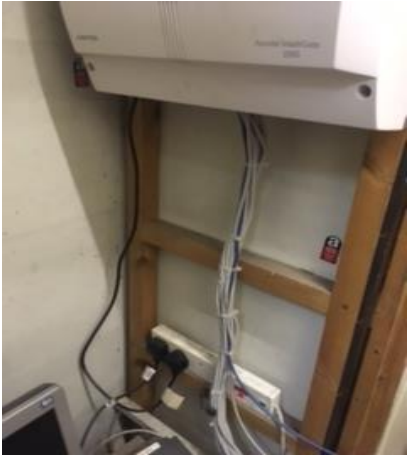
Ref	Building	Floor	Area/Room	Position
1217	Main	Ground	Store	Wall

Material Description		Material Risk
	AIB wall		6
	Additional Information		Priority Risk
	Item was in good condition		2
	HSE Notifiable/Licensed	Yes	Total Score
	Recommendation	Manage	8
Review Timescale	12 Months

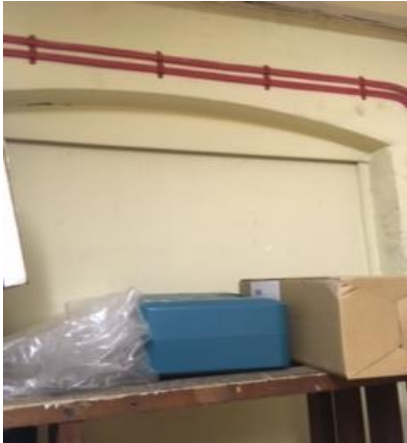
Ref	Building	Floor	Area/Room	Position
1215	Main	Ground	Store	Window

Material Description		Material Risk
	Cement infill panel		3
	Additional Information		Priority Risk
	Item was in good condition		2
HSE Notifiable/Licensed		No	Total Score
Recommendation		Manage	5
Review Timescale		12 Months

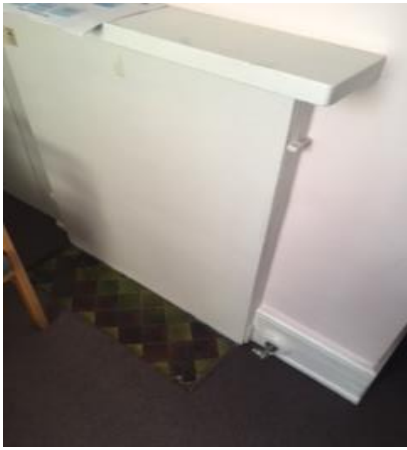
Ref	Building	Floor	Area/Room	Position
1210	Main	First	1 st Floor office	Wall

Material Description		Material Risk
	Cement Panel to Fireplace		5
	Additional Information		Priority Risk
	Item was in good condition		4
	HSE Notifiable/Licensed	No	Total Score
	Recommendation	Manage	9
Review Timescale	12 Months

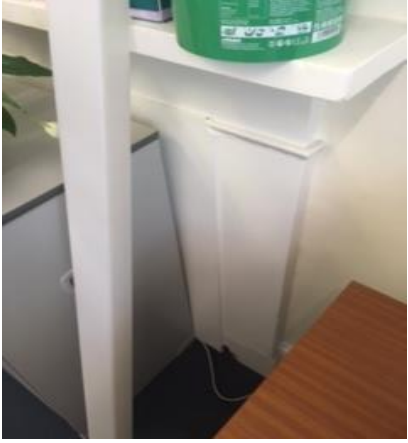
Ref	Building	Floor	Area/Room	Position
1199	Main	First	Office 6	Wall

Material Description		Material Risk
	AIB Panel to Fireplace		6
	Additional Information		Priority Risk
	Item was in good condition		4
	HSE Notifiable/Licensed	Yes	Total Score
	Recommendation	Manage	10
Review Timescale	12 Months

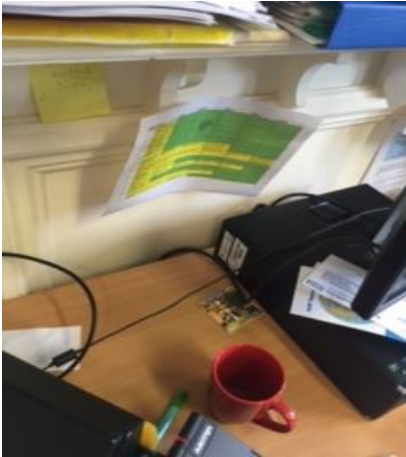
Ref	Building	Floor	Area/Room	Position
1198	Main	First	Secretaries office	Wall

Material Description		Material Risk
	AIB Panel to Fireplace		3
	Additional Information		Priority Risk
	Item was in good condition		4
	HSE Notifiable/Licensed	Yes	Total Score
Recommendation	Manage	7	
Review Timescale	12 Months

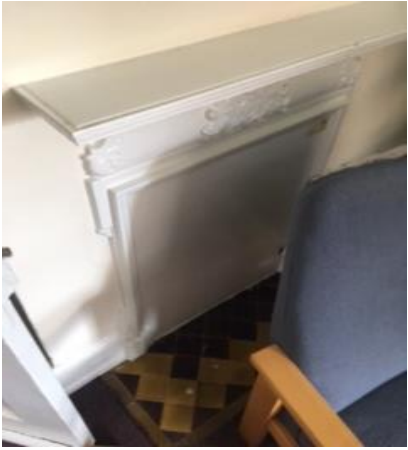
Ref	Building	Floor	Area/Room	Position
1205	Main	First	Consulting room 11	Wall

Material Description		Material Risk
	Cement Panel to Fireplace		3
	Additional Information		Priority Risk
	Item was in good condition		4
	HSE Notifiable/Licensed	No	Total Score
Recommendation	Manage	7	
Review Timescale	12 Months

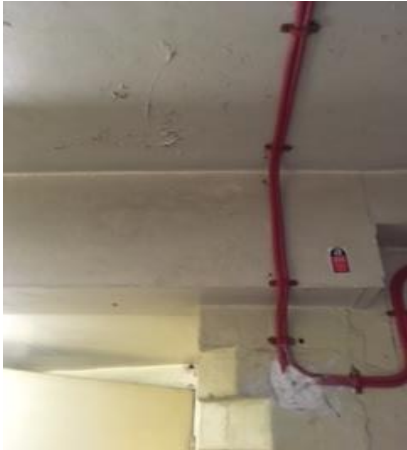
Ref	Building	Floor	Area/Room	Position
1221	Main	Ground	2 Basement Foyer	Ceiling

Material Description		Material Risk
	AIB Chimney infill panel		6
	Additional Information		Priority Risk
	Item was in good condition		2
	HSE Notifiable/Licensed	Yes	Total Score
	Recommendation	Manage	8
Review Timescale	12 Months

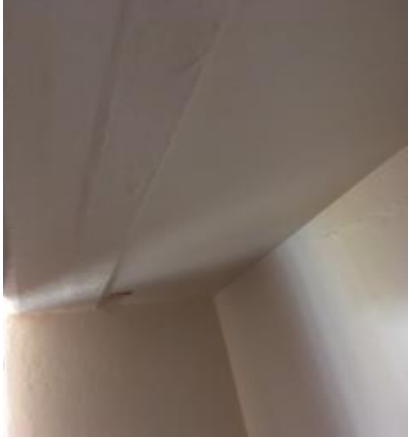
Ref	Building	Floor	Area/Room	Position
1220	Main	Ground	Office 29	Wall

Material Description		Material Risk
	AIB panel to chimney		5
	Additional Information		Priority Risk
	Item was in good condition		4
HSE Notifiable/Licensed		Yes	Total Score
Recommendation		Manage	9
Review Timescale		12 Months
